Marine Safety Forum – Safety Flash 12-46

Issued: 5th December 2012

Subject: Senhouse Slip

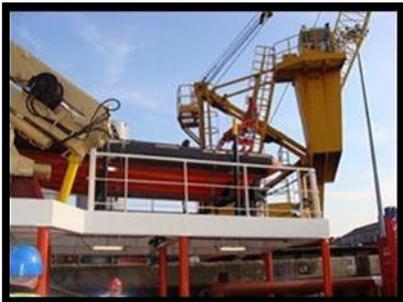
Pic 1

The deck crew had been in the process of chipping parts of the boat deck prior to painting. The vessel in question has a spare FRC located on a platform (pic 1). Space around the FRC is very limited and the aft end of the platform has 2 safety chains (pic 2) across which need to be removed when launching the spare FRC.

- Review your Task Specific Risk Assessments to ensure that they cover the areas of use and that they actually take into account the work areas that they cover and any hazards associated with these areas. We would not necessarily expect the Senhouse slip to have been noticed, but the hazards associated with moving and working in the area, should have identified moving the FRC to make the area safer to work in.

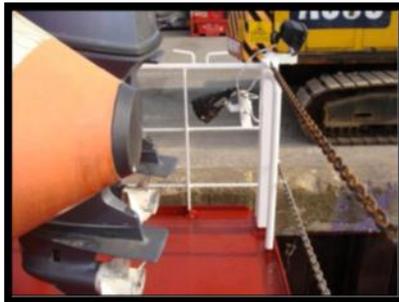
Pic 2

The I.P was helping to clear up the loose chippings and was in the process of squeezing between the safety chains and the FRC engines. As he squeezed past the outboard engines, his back pushed against the Senhouse slip on the top safety chain and released it unexpectedly. This caused the I.P to fall down onto the cargo deck.

Safety chains should be reasonably tight to do their job correctly and this will also make the Senhouse slip more secure as it will apply friction to the release ring making it harder to slide. The safety chains in question were hanging pretty slack at the time of the incident as evidenced by Pic 4. This shows the Senhouse that released at the top and the bottom safety chain below it can be seen to be hanging very slack.

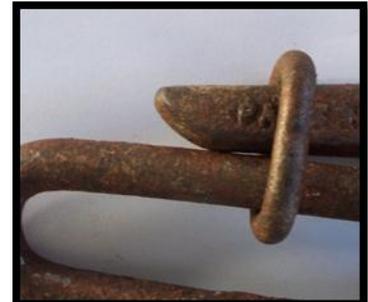
Pic 3

- There was no task specific Risk Assessment for the work being carried out at the time i.e. chipping the boat deck and platform area.
- Safety Chains were not as tight as they should have been.
- Upon investigation, Senhouse slips have changed and no longer have the lip on the end of the arm to prevent accidental release Pic 3.

- On receipt of this Safety Alert all Senhouse slips on board your vessel used for safety chains are checked to ensure that they are the type with a curve/bump/lip on the end of the arm to prevent accidental release. Don't forget any spares tucked away by the Bosun or in the deck store.

- Once all the safety chains have been checked on board and the crew made aware of the location of any straight armed Senhouse slips, Please contact the office, copying in your Superintendent and safety, detailing how many of the straight Senhouse slips you have on board.
