Marine Safety Forum – Safety Flash 12-13

Issued: 20th March 2012

Subject: Snagging Damage

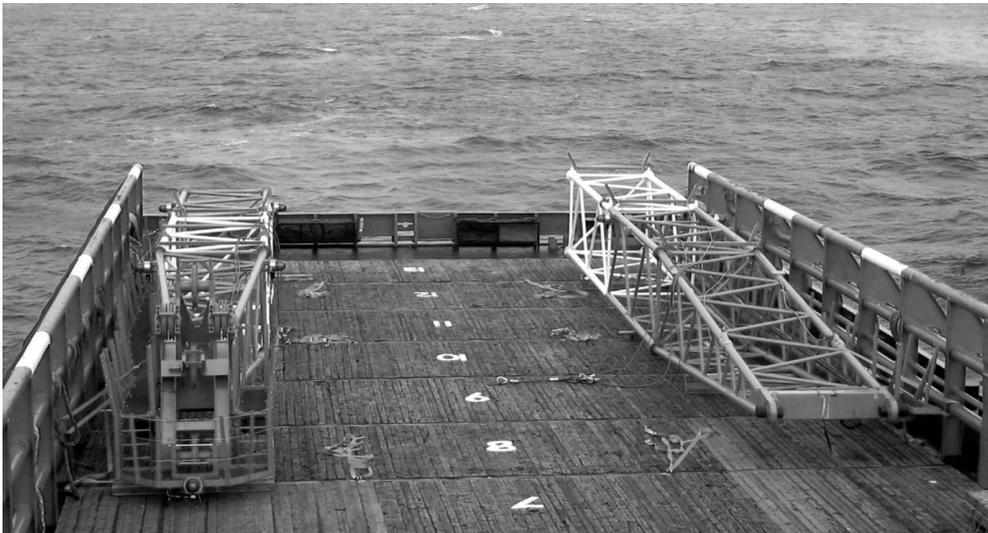
As a consequence the boom sections were loaded close to the crash barriers with the walkways towards the crash barriers on the vessel.

Crane Boom Section Loaded on PSV

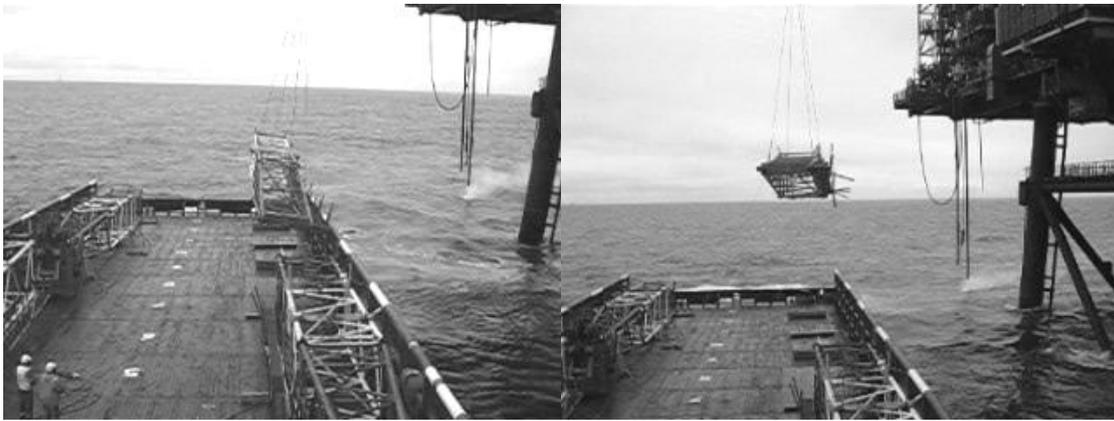
During the discharge of one of the crane boom sections from the portside of the vessel deck the walkway on the boom section snagged on the vessel crash barrier, damaging the walkway.

Walkway Snags

Damaged Walkway

- The Crane boom sections were improperly loaded onto the vessel, which lead to the damage being sustained during the lift from the vessel.

- The incident was caused by the failure to identify the hazards associated with the walkway stanchions snagging on the crash barriers. There was no risk assessment process followed to identify the stanchions as a snagging hazard.

- The boom was designed with the lights already attached and protruding out from the boom structure. This led to the boom being loaded to try and prevent damage to the lights which inadvertently created another hazard with the walkway being a snagging hazard. There was no apparent requirement for the lights to be pre-installed. In addition, it could be argued that the walkway did not have to be pre-installed on the boom and which would have removed the requirement for these lifts being special lifts.
