Marine Safety Forum – Safety Flash 12-17

Issued: 28th March 2012

Subject: Grinder

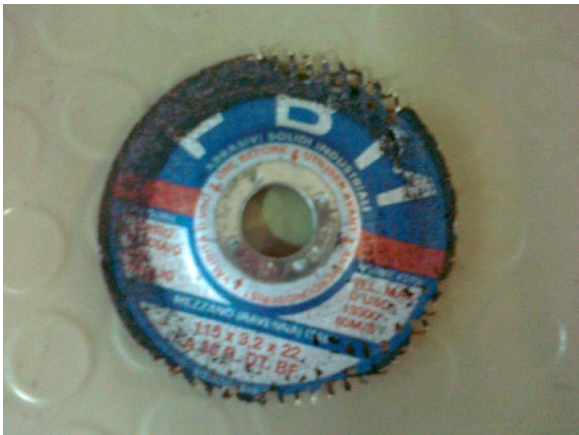
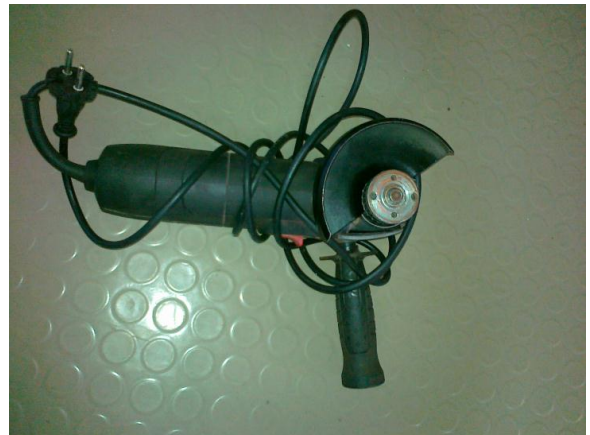
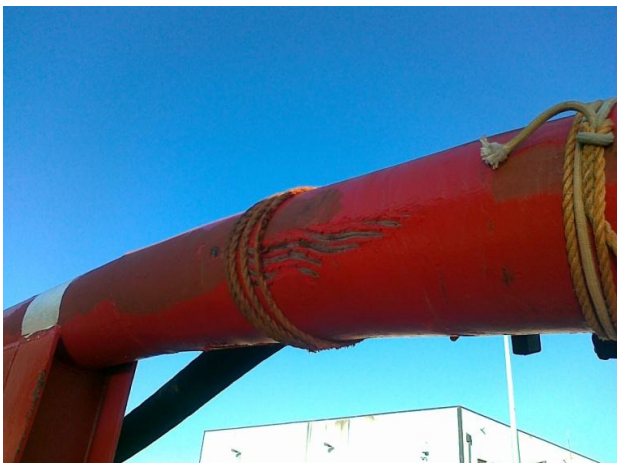
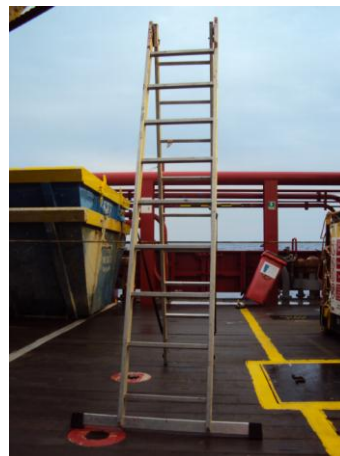
While waiting instructions from the platform, the AB Seaman has been ordered to brush the upper stern part of the crash-bar (starboard side) with an electric grinding machine. While performing the above mentioned activity, on top of a ladder, the seaman lost his balance and the control of the electric tool, dropping it on the deck. The “uncontrolled” grinder reached the body of the seaman (just above the right knee) causing the cut.

- The grinder even if built in conformity to European Legislation (CE Marked) has no emergency stop system in place. The grinder continued its rotational movement once it was not under the control of the AB Seaman, resulting in cutting the seafarer and the wood deck;
- Improper position to perform the activity (on top of a ladder) and ladder not properly secured;
- Deck space not sufficient to perform maintenance activity and reported slippery;
- The status of the crash-bar and the planned activity for the future do not justify the urgency to perform the specific maintenance activity during the stand-by position.

- Inventory of the portable power tools available onboard vessels and replacement of the ones without emergency stop system;
- Issue instruction/circular aimed to rule certain maintenance activities on deck with lack of urgency in particular circumstances (e.g. potential vessel instability/unpredictable movements);
- Reinforce the personnel about the Stop the Job Authority;
- Reinforce personnel about the importance of Permit To Work, Risk Assessment and Toolbox Talk system to identify risk and become aware and reduce them;
- Issue instruction/circular aimed to limit the use of electrical tool under particular circumstances and to reinforce the proper use of support equipment (e.g. Ladder to be secured).
