High Potential Incident Alert

Santos Ltd

66

Water truck tip over

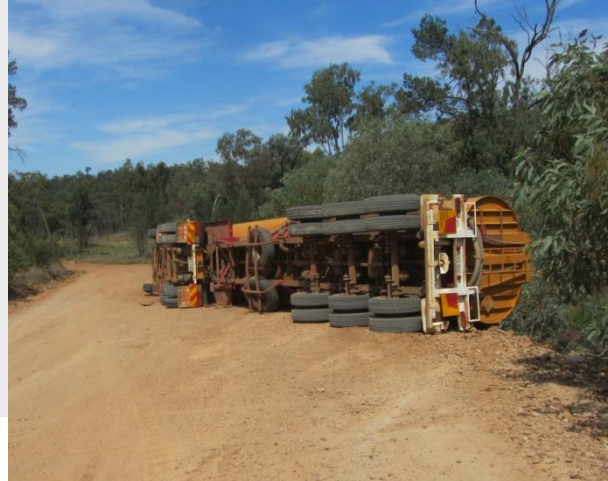
A prime mover, towing a tri-axle semi trailer (the water truck) was loaded with 25,000 litres of water. As the driver drove the water truck down the decline and rounded a curve to the left, the water truck rolled 90 degrees onto its right side.

1. Speed

- > In Vehicle Monitoring System (IVMS) data indicated the truck was travelling a 33km/hr at the point of tip over.
- > Speeds above 20km/hr on descent, and above 10 km/hr on the curve were determined inappropriate for a heavy vehicle descending the road decline.

2. Management of Change

- > Tanker converted from oil to water cartage.
- > Water heavier than oil, therefore tanker could not be fully filled.
- > No longitudinal baffling allowing sideways sloshing when cornering, increasing propensity to tip over.

- > Review suitability of speed limits for all steep inclines/declines.
- > Signage advising maximum speed limits and heavy vehicle gear selection on steep gradient roads.
- > Audit compliance of horizontal and longitudinal baffling in liquid tankers.
