Marine Safety Forum – Safety Flash 12-16

Subject: Gangway Finger Injury

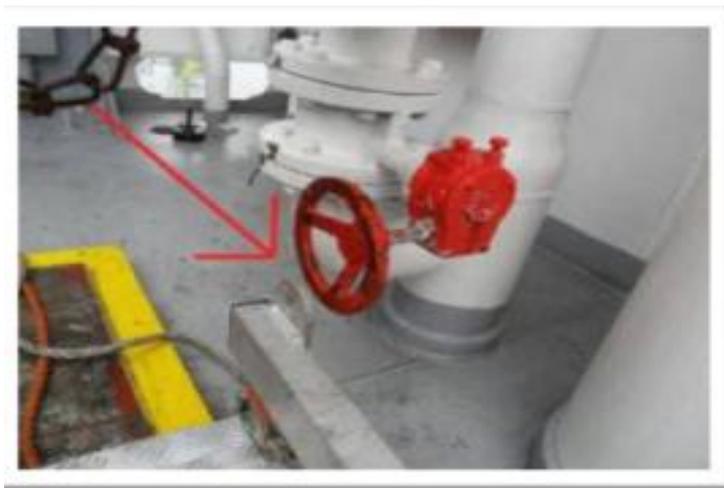
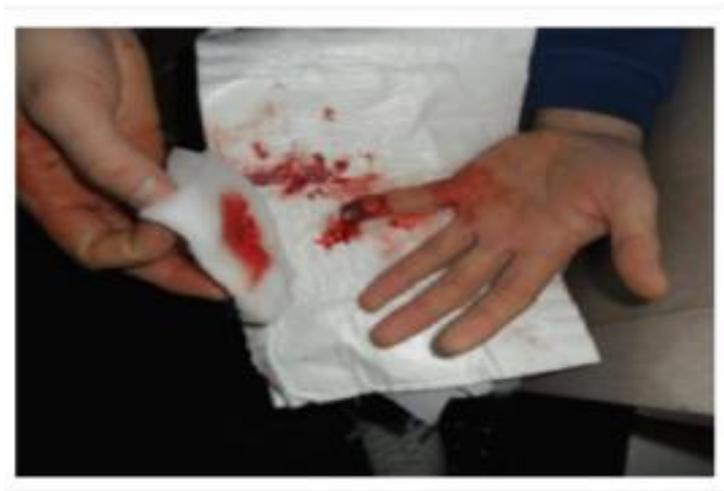
When putting the gangway in storage position for sea passage, the gangway was picked up, and the gangway moved to the left causing a finger to get trapped in between gangway and fire hydrant manifold. All safety measures were taken and toolbox / Risk Assessment were made.

During preparation for departure 2 ABs and the Second Officer were tasked with removing and stowing the ship's gangway. The gangway was lifted onboard and whilst it was being slid along the deck for stowage, one AB had his finger pinched between the gangway frame and an isolation valve on deck resulting in a deep cut to his finger. The Chief Officer started to carry out first aid to stop the bleeding. The Captain contacted the agent to arrange transportation for the Injured Person to hospital and informed the office (ERT) of the accident. The AB was transferred to hospital where he received further treatment before returning to the ship. On his return, the Captain made the decision that the AB would not be fit for duty and that he should return home to recover fully. The AB was off duty for 5 weeks.

The Store crane was out of order and awaiting repairs. Therefore a smaller gangway was being used that allowed for crew members to manually handle it into position.

The Risk Assessment did not identify any pinch areas, nor had the isolation valve been highlighted as a potential danger.

- Vessel RA to be re-assessed to identify all risks involved in manually handling gangway
- Rotate valve so will not be possible to pinch finger
- Investigate alternative gangway storage facility one deck higher than the main deck on the aft of the accommodation. The gangway will be positioned as far possible to port side to establish easy handling and positioning of the gangway by the crane
- Management of Change procedure and forms to be rolled out and emphasized
- Report to be discussed with master in respect of use of toolbox and Risk Assessments
