Marine Safety Forum – Safety Flash 12-19

Issued: 30th March 2012

Subject: Fracture to Right Foot

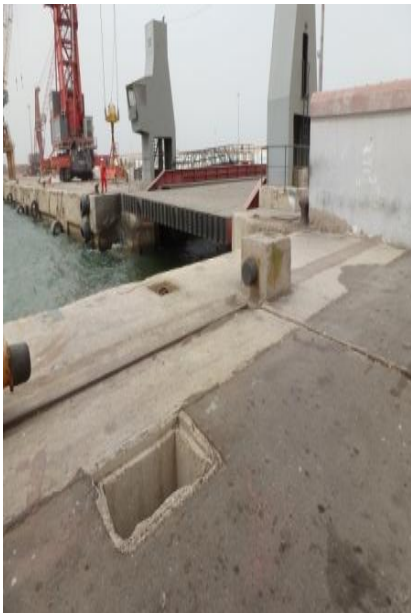
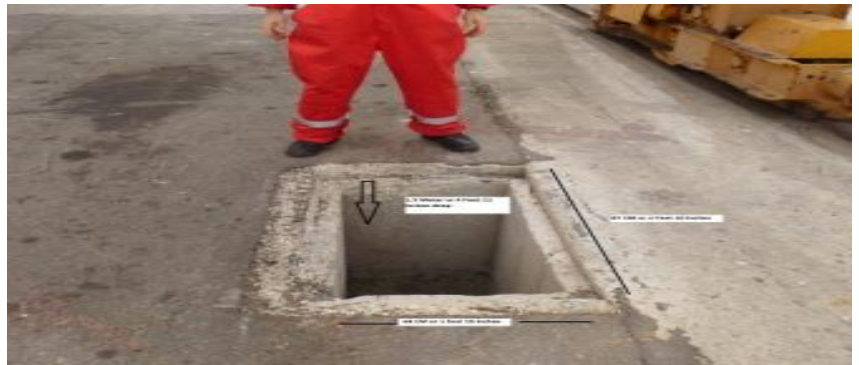
Able Seaman fell in unmarked drain or manhole on quay wall.

- No grid over deep drain or manhole, no hazard marking around the hole.
- Able Seaman not familiar with the area.

- Watch your step when walking around all areas, especially when not familiar with the area.
- All areas should be examined so that slips trips and falls hazards are identified prior to commencement of any operations.
- All hazardous areas should be clearly marked.
- Having identified hazards, Risk Assessments are to be carried out.
- Use the risk assessment in consultation with the crew members to determine the best means of elimination and controlling the risk.
