# High Potential Incident Alert

## Excavator cab windscreen impacted by high velocity projectile

# 68

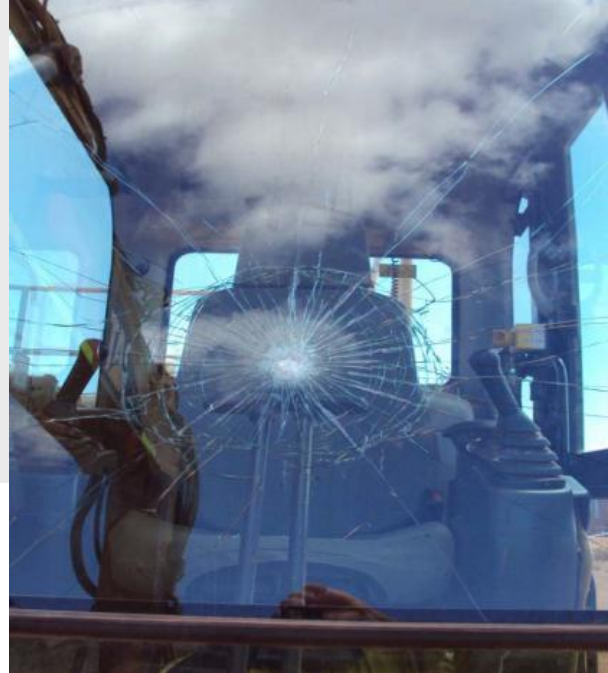
During demolition works, an excavator with a hydraulic pipe cutting attachment was being used to move (not cut) a section of pipe with a 3/4 inch ball valve attached. During the move the jaws sheared through the valve into a projectile which struck the excavator cabin window at high velocity. The glass withstood the impact and the operator was not injured.

- > *Always use the correct tool for the job.*
- > *Use protective window mesh screening during high risk demolition works.*
