Marine Safety Forum – Safety Flash 12-24

Subject: Accidental Discharge of CO2 Fire Extinguisher

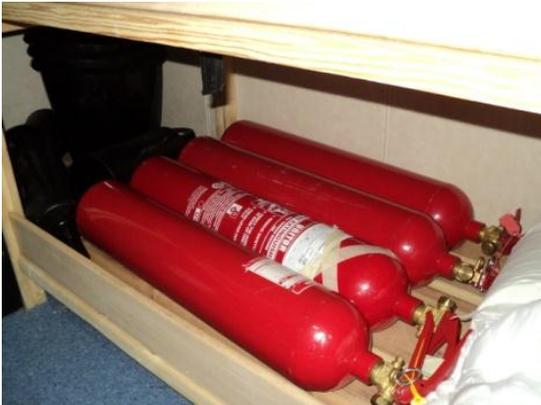
Whilst on location, in what was described as moderate sea conditions, one of our vessel crew members was alerted by an “unfamiliar loud” noise, on investigation it was discovered that a spare CO2 Fire extinguisher in the ships store had partially discharged. The vessels spare extinguishers were stored in the deck store, horizontally on a shelf, over a period of time, due to the natural movement of the vessel the security tag had worn through. This had led to the pin falling out and the trigger mechanism was activated for a short period. The cause was identified as the extinguisher not being secured.

Original Stow picture

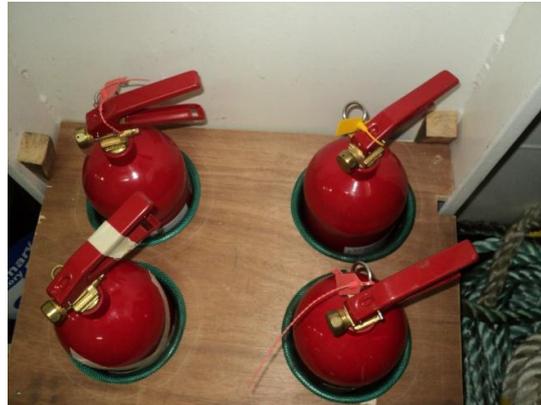
Modified Stow picture

On this occasion the consequences were negligible. Prolonged activation and subsequent release of the extinguisher could possibly result in an oxygen deficient atmosphere in the store area. Every vessel must ensure that items are suitably secured against vessel movements, in particular Life Saving Equipment. I realise that not every vessel will have a crewmember with the skills to manufacture such a frame. All vessels will have crewmembers with the skills to secure cylindrical equipment from rolling about. A few strategically placed wedges between the slats in the shelves or even a strategically placed bundle of clothes would suffice in the short term. Although I am sure you will agree the frame is much more effective and tidy. Well done to the crewmembers involved in the manufacturing of the frame, although I would question why the extinguishers were stored loose in the first instance?
